# Manhole Inspection Summary

Manhole # S33M\_\_014MH

Insp Date: **9/3/09 11:04 AM**

**Location** Address: **701 S.Sharp St.**

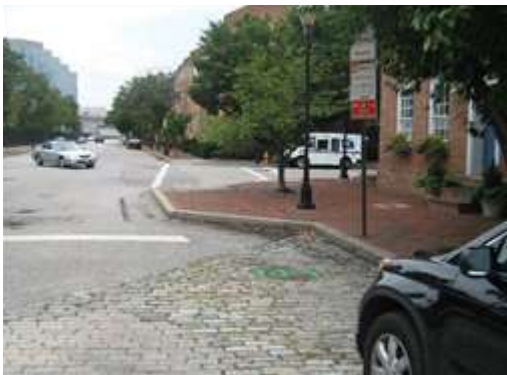
Location View

View facing north

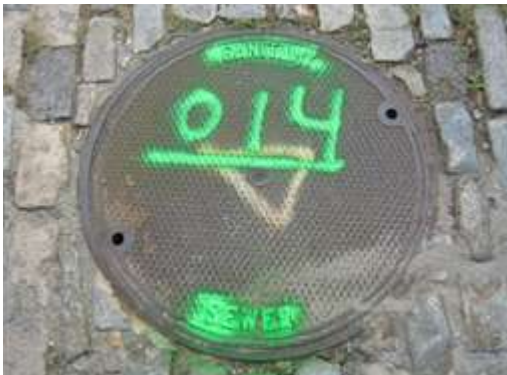
Miscellaneous

MH Lid

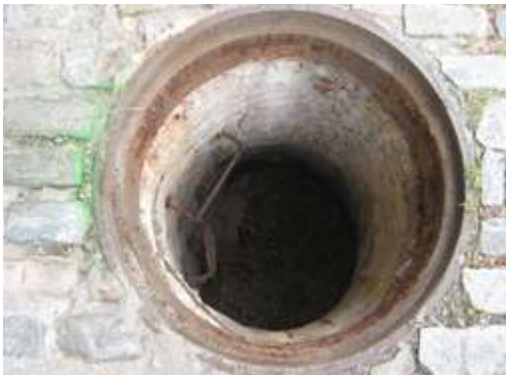
Miscellaneous

Frame View

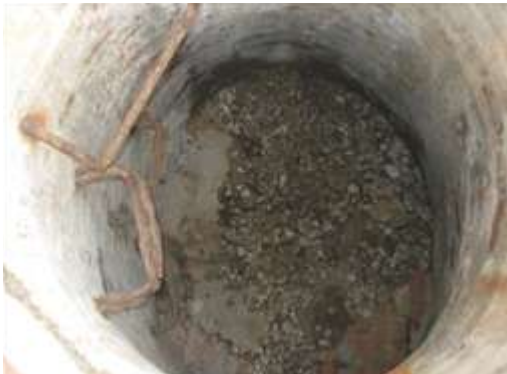
Defect 4

Condition: ☐ Sound ☐ Cracked ☐ Root Intrusion ☐ Deteriorated ☐ Leaks ☒ **Debris**

bench debris

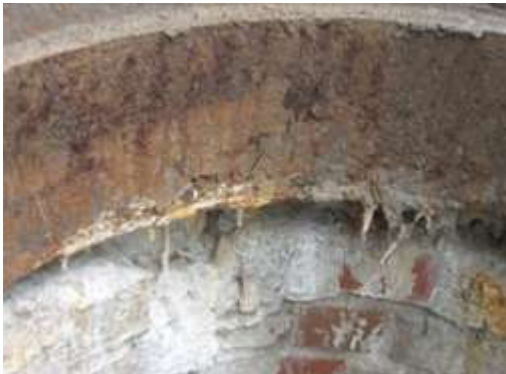
Defect 5

☒ **Leaks**

frame leaking

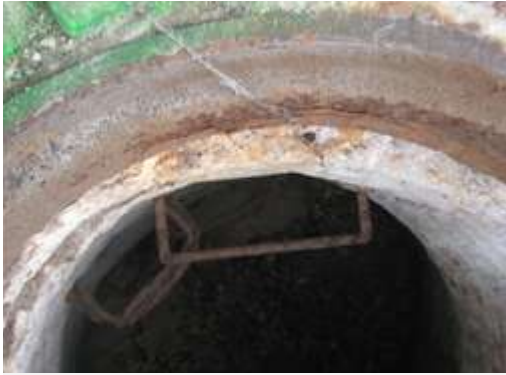
Defect 3

Offset: **1.5** (in.)

frame offset

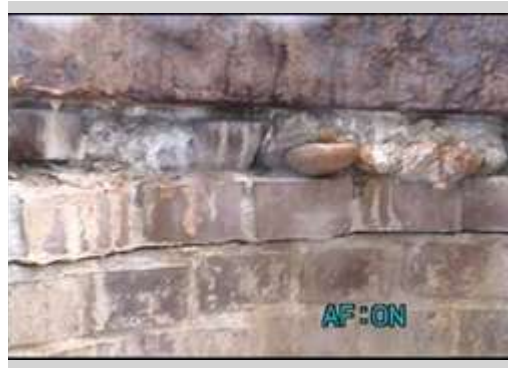
Defect 2

Condition: ☐ Sound ☐ Cracked ☐ Root Intrusion ☐ Loose Brick ☒ **Deteriorated**

deteriorated chimney

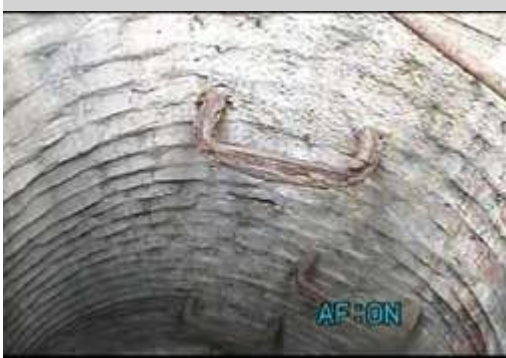
Defect 1

Count: **4** Missing: **0** ☒ **Corroded**

corroded rungs

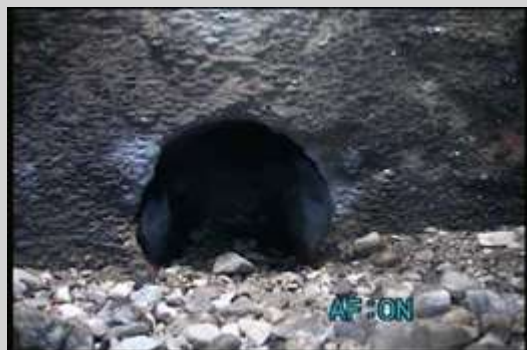
12 O'Clock Outflow

10 in. Circular Gravity Sewer  
Pipe Out @ 12 O'Clock
